Immediate installation with gingival flap

Immediate placement of a Fixture 4.5 ST after longitudinal root fracture of right central incisor (11). Two-stage surgery performed due to lack of initial stability. At the abutment surgery, a buccal flap elevation with mucosal reposition is made to improve the esthetic result.

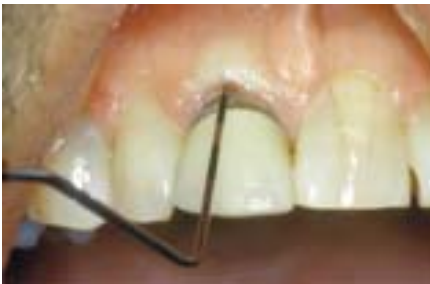
1. Buccal root fracture diagnosed with an excessive pocket depth.

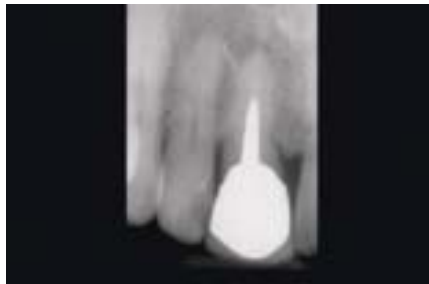
2. X-ray showing apical destruction and indicating a longitudinal root fracture.

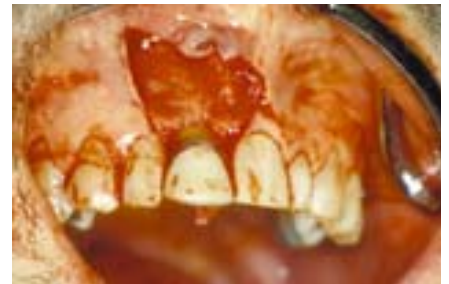
3. A buccal flap is raised before careful extraction and immediate implant installation.

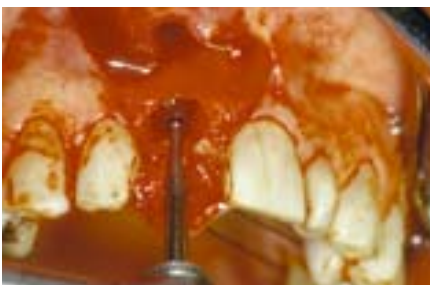
4. The correct direction for the implant insertion is outlined with a Guide Drill.

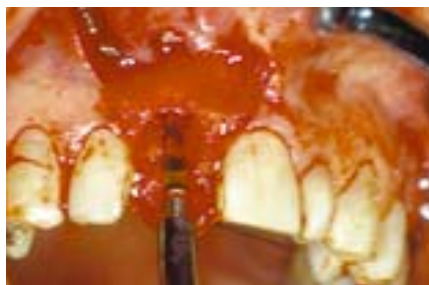
5. The drilling procedure is continued and the insertion path is widened with the use of Tiger Drill.

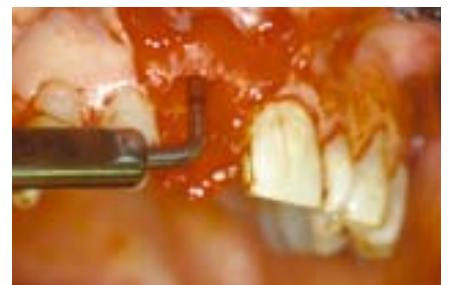
6. Correct depth is verified with Depth Gauge.

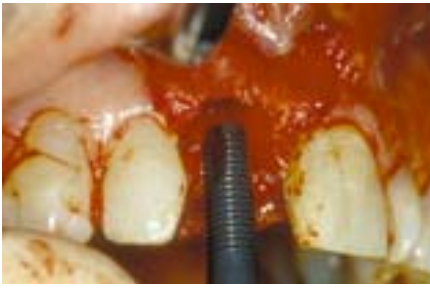
7. Ready for implant installation of a Fixture 4.5. Saline at hand for irrigation.

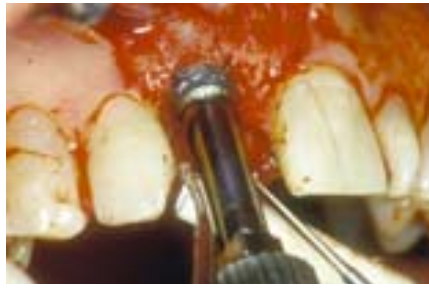
8. Implant installation with Fixture Adapter, Long, attached to the contra angle. Maximum speed 20 rpm and heavy irrigation.

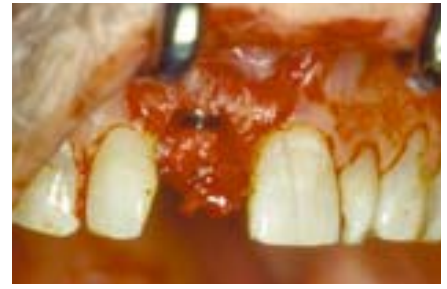
9. Buccal view of the installed fixture showing the neck situated at the marginal bone level.

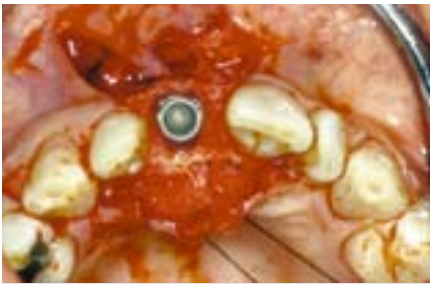
10. Occlusal view demonstrates a small gap surrounding the fixture. The primary stability is dubious.

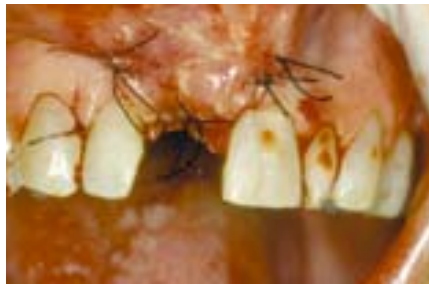
11. Due to the unstable situation, a stage protocol is chosen. Tight suturing for full cover of the fixture site.

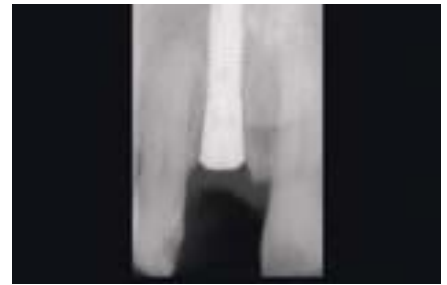
12. X-ray after immediate installation surgery.

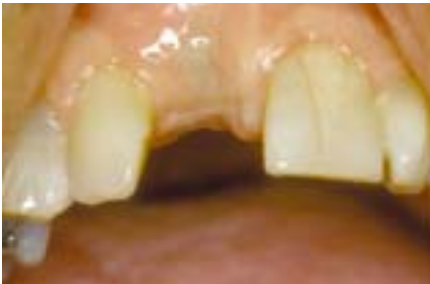
13. After a healing period of four months, a gray shadow is visible through the thin buccal mucosa. A decision is taken to improve this situation in conjunction with abutment installation.

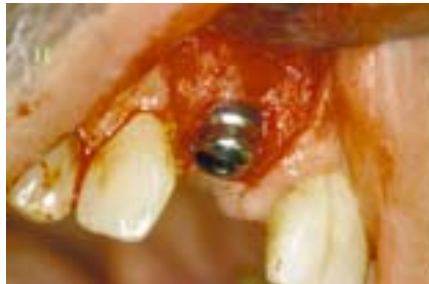
14. Buccal view after flap elevation and Healing Abutment installation.

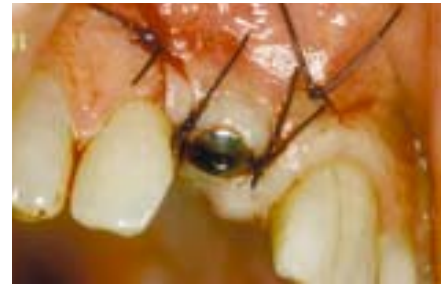
15. The flap is gingivally repositioned and sutured tightly to improve the buccal mucosal thickness.

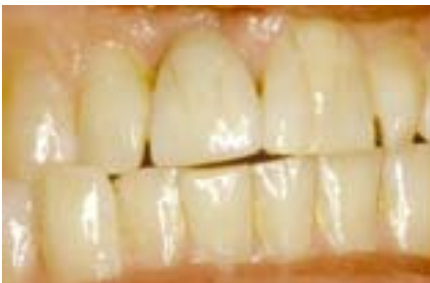
16. Final result after cementation of a porcelain fused to metal crown.

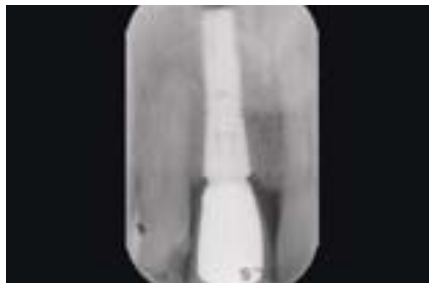
17. X-ray of 2-year follow-up.
